LAND CORNER RECORD

1. T 4S R 37E No. N17 Cor. Sec. Mer. Will State Oregon N. F. Wallowa Whitman Dist. LaGrande

CERTIFIED RECORD OF LAND CORNER MONUMENTATION

N-17

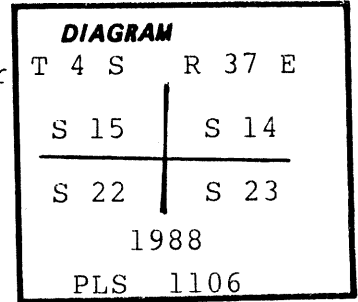
No trace of original corner stone.

- A root hole brs N80°E, about 49.5'.
- A root hole brs S40°E, about 5.3'.
- A live 24" white fir brs S50°W, 15.8' to face of blaze & 16.3' to center of tree with healed blaze.
- A down rotten white fir about 8" dia brs N20°W, 11.2' to face of blaze & 11.5' to center of root hole with some visible scribes.

Corner point was re-established by measuring record distance from the blaze faces of NW & SW original BTs.

Set a 2½" aluminum cap on 2½ x 30" aluminum pipe 24" in ground, surrounded with mound of earth only and a 6' steel fence post South of corner with sign 54-9 attached. Cap marked as shown in corner diagram.

The area has been logged and there are few acceptable trees to mark as BTs. I marked 3 new bearing trees:

- A 16" white fir brs N32½°E, 82.4' scribed T4SR37ES14 BT.
- A 7" lodgepole pine brs S64½°E, 26.1' scribed T4SR37ES23 BT.
- A 9" white fir brs N42½°W, 87.6' scribed T4SR37ES15 BT.

New BTs have a brass washer stamped PLS 1106 nailed to face of blaze. Attached sign 54-3 & 54-9, painted face of blaze & a 6" red band around each BT.
