CERTIFIED RECORD OF LAND CORNER MONUMENTATION

C-13

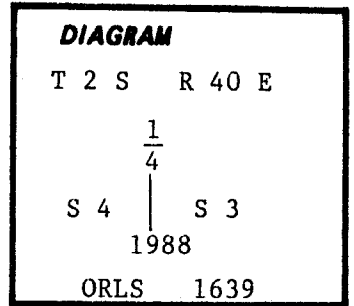
Searched 6 man-hours on 6-30-88 and 7-06-88 for original corner and accessories on steep north mountainside - several rotten stumps and evidence of old wildfire, corner declared lost.

At proportioned position between controlling Section Corners North and South...

Set 2 1/2" aluminum cap on 2" aluminum pipe 24" in ground & 6" projecting out of ground with surrounding rock mound & 6' fence post alongside with sign 54-9 attached. Cap marked as shown in corner diagram.
