CERTIFIED RECORD OF LAND CORNER MONUMENTATION

**UNION COUNTY SURVEYOR
CERTIFIED RECORD OF LAND CORNER MONUMENTATION**

LaGRANDE & ISLAND CITY, UNION COUNTY OREGON

TWP.3S, RGE.38E, W.M.

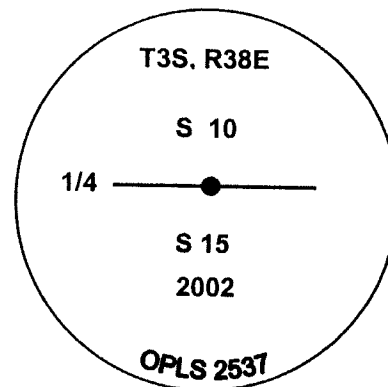
DIAGRAM

Found 2 1/2" brass cap as per record. Corner subsequently destroyed by road construction and remonumented as shown below.

At the position of the brass cap I set a 5/8" x 30" iron rod with 2" aluminum cap marked as shown, set 0.5 below grade in a monument box for the South one quarter corner of Section 10. From which:

A 3" Brass Cap in a concrete cylinder (0.5 above grade) marked "STATE HIGHWAY DEPARTMENT", "ELEVATION", "FEET", "BM No" bears N67°E, 68.9 ft.;

A 5/8" X 30" iron rod with 2" aluminum cap marked SW RP bears S45°W, 34.5 ft., set 0.1 below ground;

A 5/8" X 30" iron rod with 2" aluminum cap marked SE RP bears S46°E, 44.8 ft., set 0.1 above ground, 1.0 northwest of northeasterly angle point of metal rail fence.
