CERTIFIED RECORD OF LAND CORNER MONUMENTATION

FILE NO. 48-90R

**CERTIFIED RECORD OF LAND CORNER MONUMENTATION**

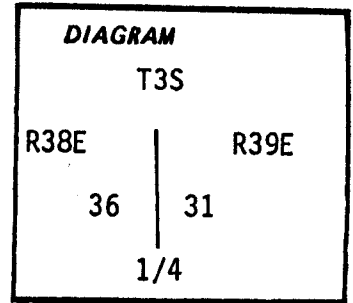
No evidence found. The Monument of Record, a 2" iron pipe described in Union County Surveys 1-74 and 33-74 was not found.

At the corner location determined as described in a survey performed for the Oregon Department of Fish and Wildlife, I set a 2"x36" aluminum pipe, 32" in the ground, with magnet-equipped aluminum cap attached, marked:

An existing 2" iron pipe with threaded cap marked "POINT OF DIVERSION NO. 2", located at the north end of an existing N-S fence, bears S3°53'20"W 10.43 feet,

A "+" chiseled on top of the NE corner of a concrete diversion structure, bears N32°39'40"W 50.40 feet,

A railroad spike driven vertically in the west base of a multi-stemmed willow tree 6'± in diameter, bears N69°51'50"E 32.88 feet, and

A 5/8"x30" iron rod (rebar) with yellow plastic cap marked "AP&A" attached, set near a railroad tie brace post, bears S82°18'20"E 60.70 feet.

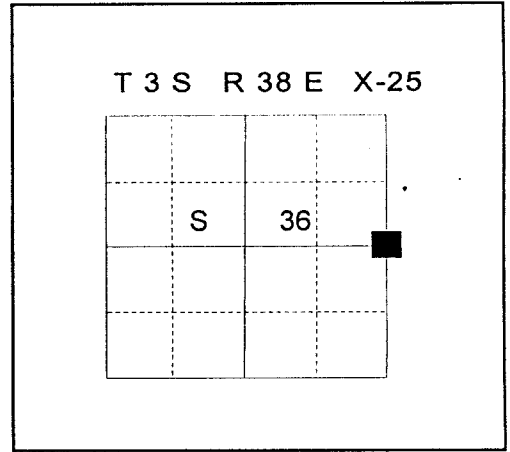
3" aluminum cap set by survey 27-90. Not accepted  
See survey Number 034-1998

At the original position of the pipe found by survey number 1-74, determined by survey, I set a 2½"x30" aluminum pipe with aluminum cap marked as shown, 24 inches in the ground from which:

A 5/8" x 30" iron pin with yellow plastic cap bears N83°E, 14.99 feet marked BGB SURVEY MARKER NE RP.

A 5/8" x 30" iron pin with 1½" aluminum cap bears S47°E, 8.20 feet marked A P & A.

A 2" iron pipe with cap bears S89°W, 45.95 feet marked STOCKHOLM USA.

A 3" aluminum cap bears N78°W, 46.29 feet marked as recorded in Union County survey 27-90.
