CERTIFIED RECORD OF LAND CORNER MONUMENTATION

FILE NO. 48-90R

**CERTIFIED RECORD OF LAND CORNER MONUMENTATION**

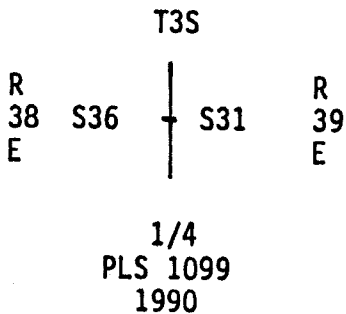
At the corner location determined as described in a survey performed for the Oregon Department of Fish and Wildlife, I set a 2"x36" aluminum pipe, 32" in the ground, with magnet-equipped aluminum cap attached, marked:

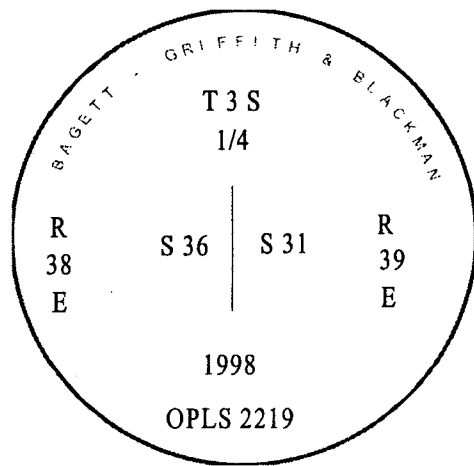
At the original position of the pipe found by survey number 1-74, determined by survey, I set a 2½"x30" aluminum pipe with aluminum cap marked as shown, 24 inches in the ground from which:
