CERTIFIED RECORD OF LAND CORNER MONUMENTATION

T 2 N R 39 E O-20

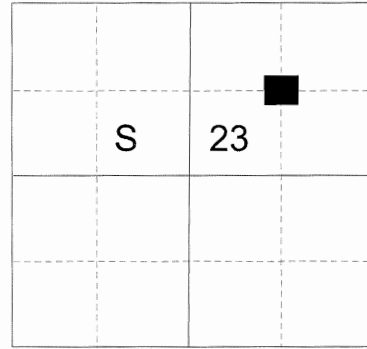
At position determined by survey, I set a 5/8" x 30" iron pin, 25 inches in the ground, with 2' collar of stone, from which:

A 5" White Fir bears North 82° East, a distance of 7.60 feet, marked X BT.

A 7" Douglas Fir bears South 66° West, a distance of 21.15 feet, marked NE 1/16 S23 BT.

Remnants of East and West running barb wire fence bears approx. 15 feet South.

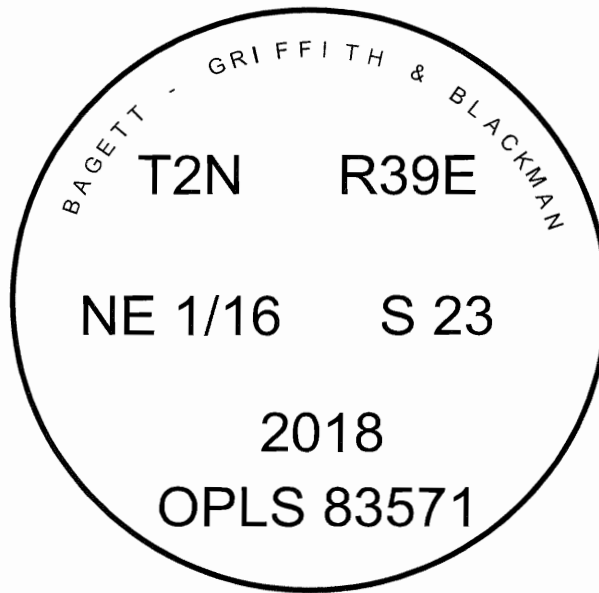
I use a steel tape and magnetic compass in the establishment of the bearing trees. Magnetic declination used was 15° East. Distances are to a spike in the root crown of the trees. Bearings are to a brass washer in the lower blaze marked OPLS 83571.
