**STATEMENT**

**Basis of Bearing**

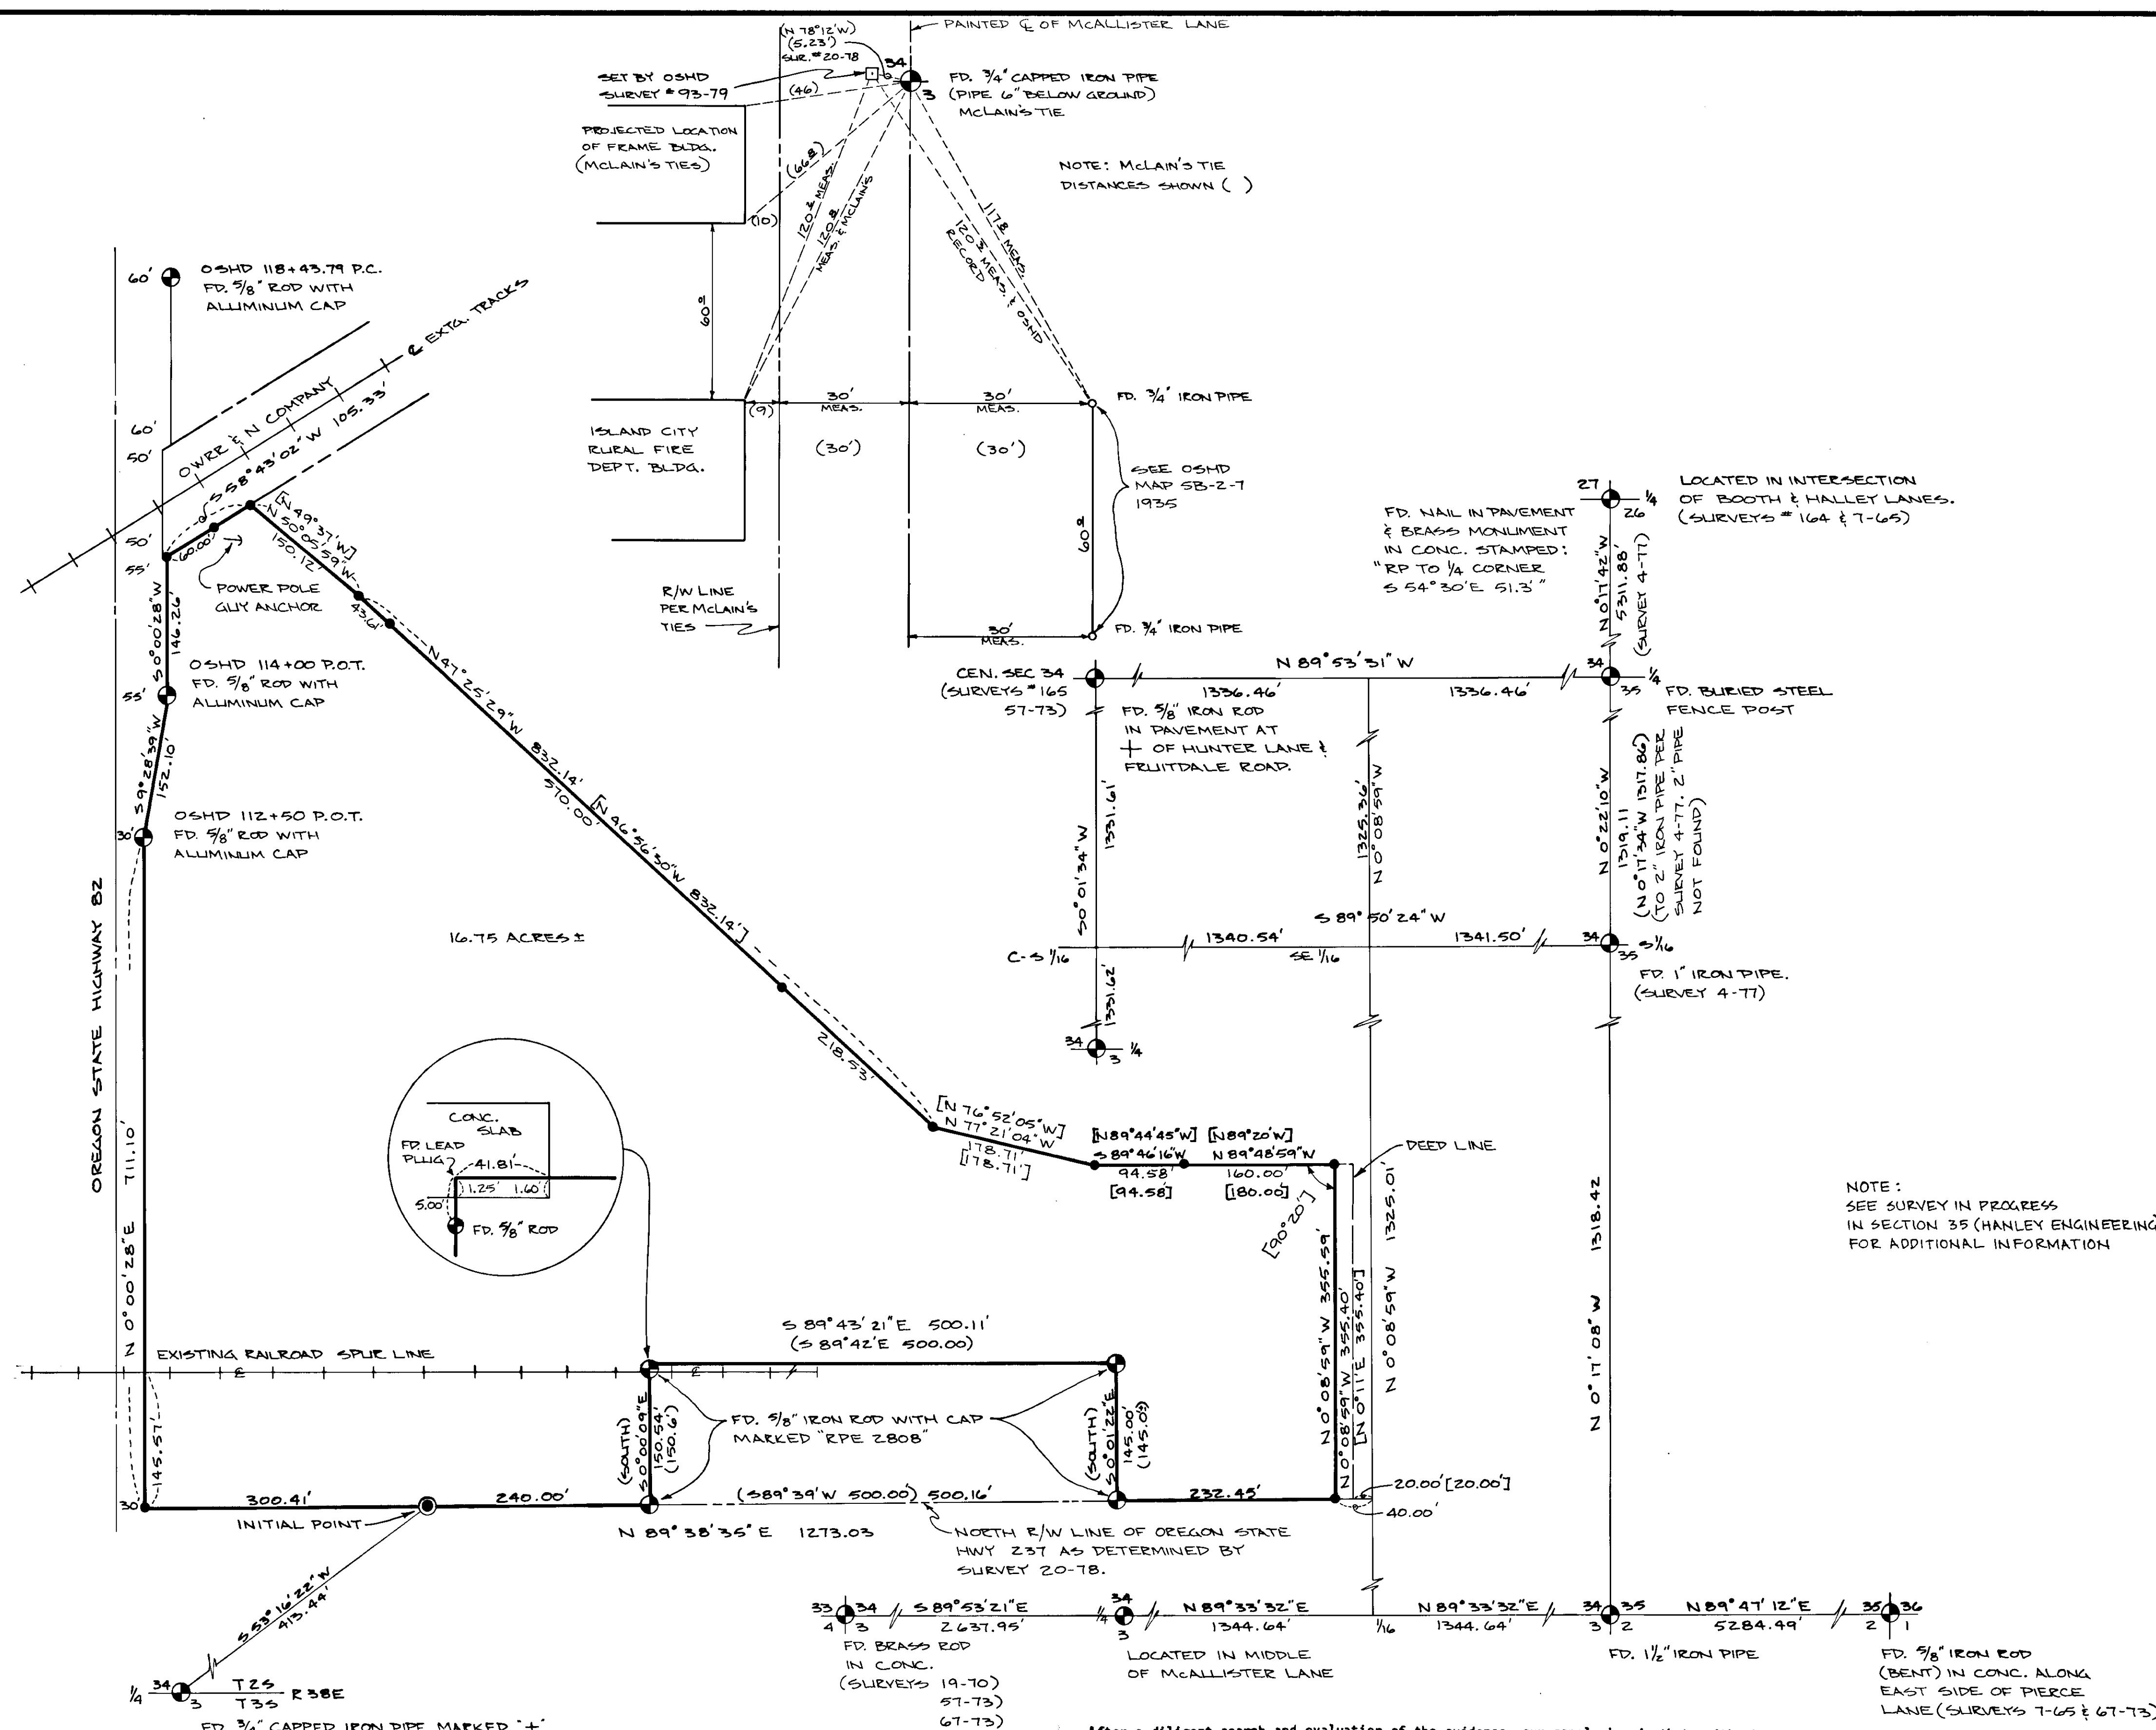
A 1" Iron pipe buried along the West side of a gravelled lane marks the correct position of the S 1/16 corner common to Sections 34 and 35, T. 2 S., R. 38 E., W.M.;

A section of "T" steel fence post buried along the West side of a gravelled lane, South of Oregon State Hwy. 82 marks the correct position of the 1/4 corner common to Sections 34 and 35, T. 2 S., R. 38 E., W.M.;

We note that Record Survey No. 4-77 (By J. G. Voelz) shows a found 2" Iron pipe at a point verified by our measurement to be essentially at the position of the found "T" steel fence post described above as the 1/4 corner. We were unable to find a 2" Iron pipe at this location, however, Mr. Voelz verified that the "T" steel fence post is at the correct 1/4 corner position.

BEARINGS ARE BASED ON THE OREGON STATE PLANE COORDINATE SYSTEM, NORTH ZONE, USING A COLLEGE 1946 LISC & CAS AND THE AZIMUTH TO THE KLBM RADIO MAST AS PUBLISHED BY THE LISC & CAS, REVISED 1973. MAPPING ANGLE = +1°44'36"

As noted on Record Survey 93-79, two monumented positions presently exist for the 1/4 corner common to Section 34, T.2S., R.38E., and Section 3, T.3S., R.38E., W.M. One monument is a 3/4" Capped Iron Pipe, marked "A" which agrees with reference ties established by A.H. McLain in 1932. McLain's ties can be found in his personal set of Metsker Maps which are now in the custody of James G. Voelz, Union County Surveyor. The second monument was established in 1973 by the Oregon State Highway Division from a reference tie shown on the 1935 OSHD R/W Map 58-2-7 of the Cove Secondary Highway (Record Survey 93-79).

Both records refer to a "Pipe" at the corner location: Distance to the existing centerline of McAllister Lane and to the NE corner of the Island City Rural Fire Dept. Building from a found 3/4" I. Pipe at the NW corner of Block 2, Sterlings Addition as shown on OSHD Map 58-2-7 are in agreement with the set-back and street dimensions shown on "McLain's Ties"; The found 3/4" I. Pipe at the apparent NW corner of Block 2, Sterlings Addition is in good alignment with the north side of the Fire Dept. Building.
