This survey was ordered by Mike Becker in order to establish the exterior as well as the proper section break for LITTLE CREEK ADDITION. This survey was also prepared in order to establish the property lines along the South East portion of Mr. Becker's property.

UNION COUNTY SURVEYOR
 Date Received 1-19-98
 Date Filed 2-18-98
 By: R. Robinson, Deputy
 File No. 003-1998

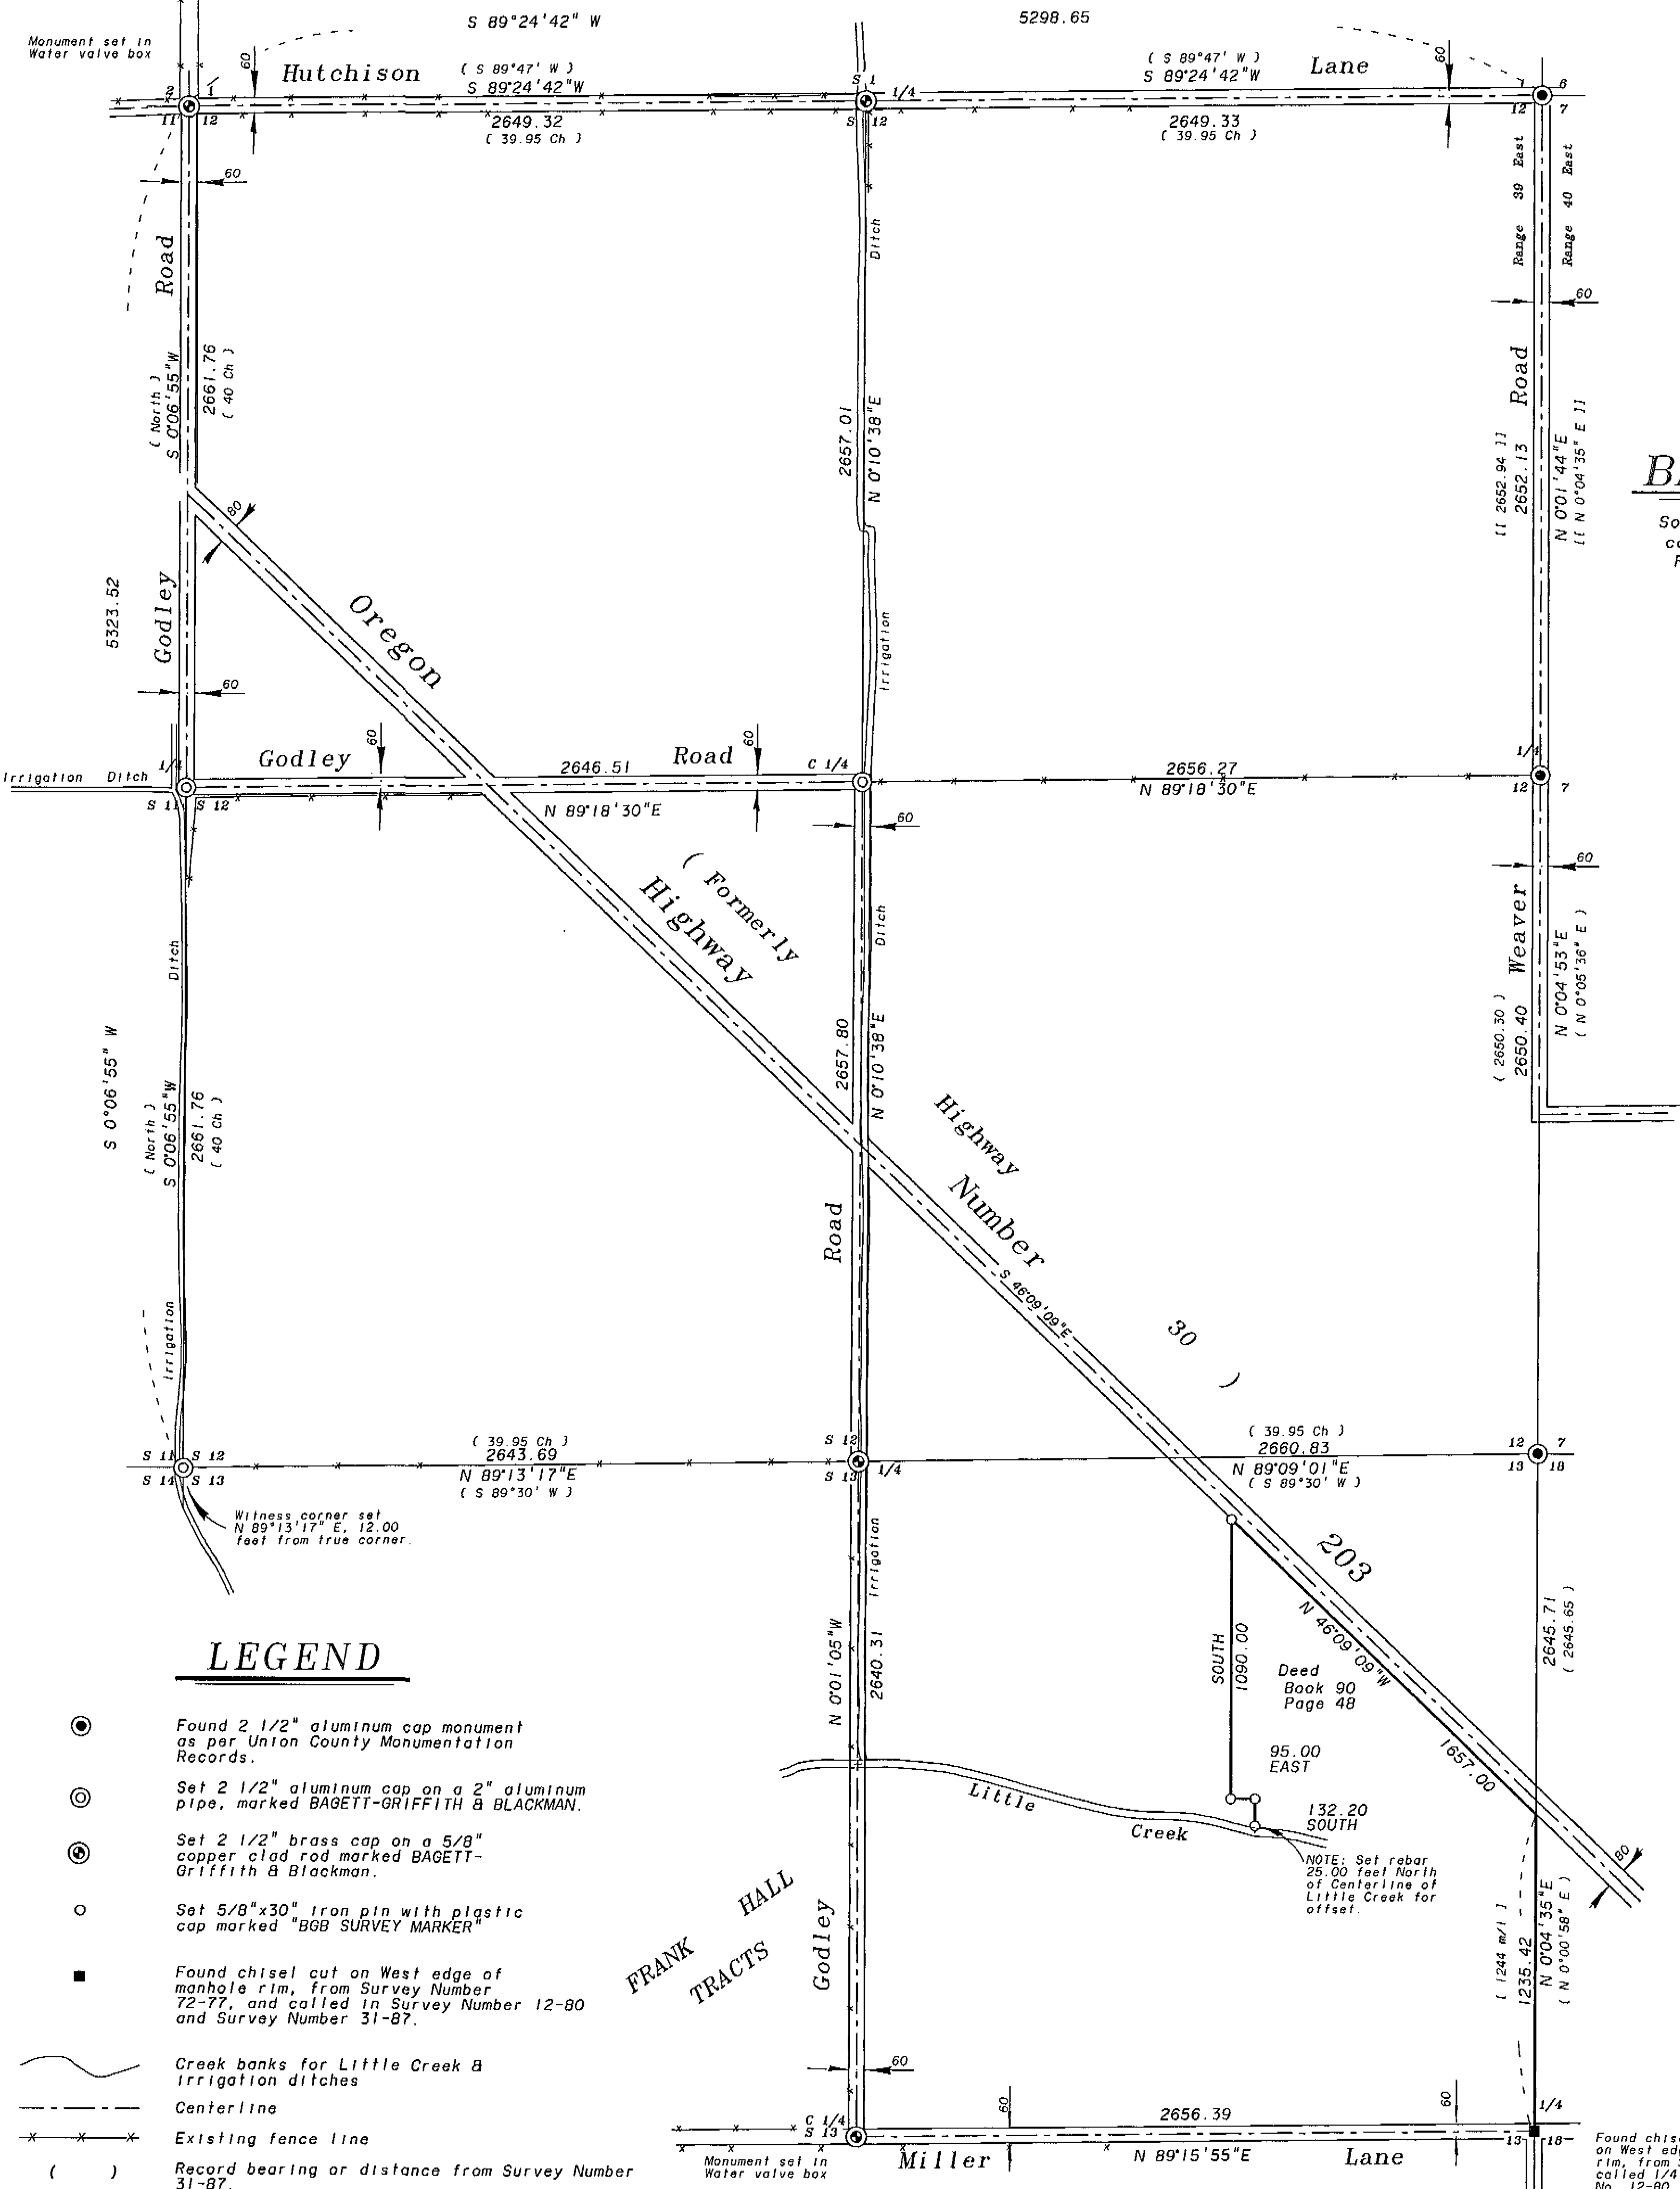
BASIS OF BEARING
 Solar observation taken at the Southeast corner of Section 13, Township 4 South, Range 39 East of the Willamette Meridian.
SCALE: 1"=400'

I found that the Range line between 39 East and 40 East had been established by Survey Number 14-71. Survey Number 31-87 found the Section corner at 7-12-13-18. All of the corners along the Range line were remonumented by the Union County Surveyor, with the exceptions of the steel pipe at the Section Corner at 13-18-19-24, and the chisel cut on the rim of a manhole in Bryan Avenue for the 1/4 corner between Sections 13 and 18. The chisel mark was established from subdivision ties on Survey Number 72-77 and called the 1/4 corner by Survey Numbers 12-80 and 31-87. I accept this chisel mark as the 1/4 corner. I establish the Northwest corner of Section 12 by Union County road records. The road survey for GODLEY ROAD shows and calls the centerline as following the section lines and center of section lines. I tie the fences and center lines of the roads as they exist on the ground and establish the intersection of Godley Road and Hutchinson Lane from the existing evidence. There is a record of a stone along Hutchinson Lane 30 feet west of the Section corner. I did not find the stone. It appears that the roads had been rebuilt and the stone was probably destroyed. The North 1/4 corner of Section 12 was established by proportion. I find that the proportion position fits a fence to the north very well. There is also a fence to the south that is offset to the East due to the fact there is an irrigation ditch west of the fence. I checked the Adjudication map of water rights in this area, and the map also shows the ditches running very close to the center of section line. It is my opinion that the fence to the south is not on the center of section line, and has been moved to give the ditch room. I establish the Southwest corner of Section 12 at the intersection of the existing fence line and the centerline of Godley Road also. I find that the overall distance from the Northwest corner of said section is consistent with the excessive measure of the rest of the section. I set the West 1/4 corner of Section 12 at proportionate distance. I find that this is also harmonious with the centerline of Godley Road to the North and East. I establish the South 1/4 corner of Section 12 at the point N 89°13'17" E, 30 feet from an existing fence corner. I
