BAGETT, GRIFFITH & BLACKMAN 2006 Adams Avenue, LaGrande, Oregon Situate in the Southeast Quarter of Section

36, Township 3 North, Range 39 East of the Willamette Meridian

Union County, Oregon SURVEYED FOR REISOM CORPORATION SURVEYED BY GTB 6/06/04 | Scale: 1" = 400 ft. | Drawn by: GTB

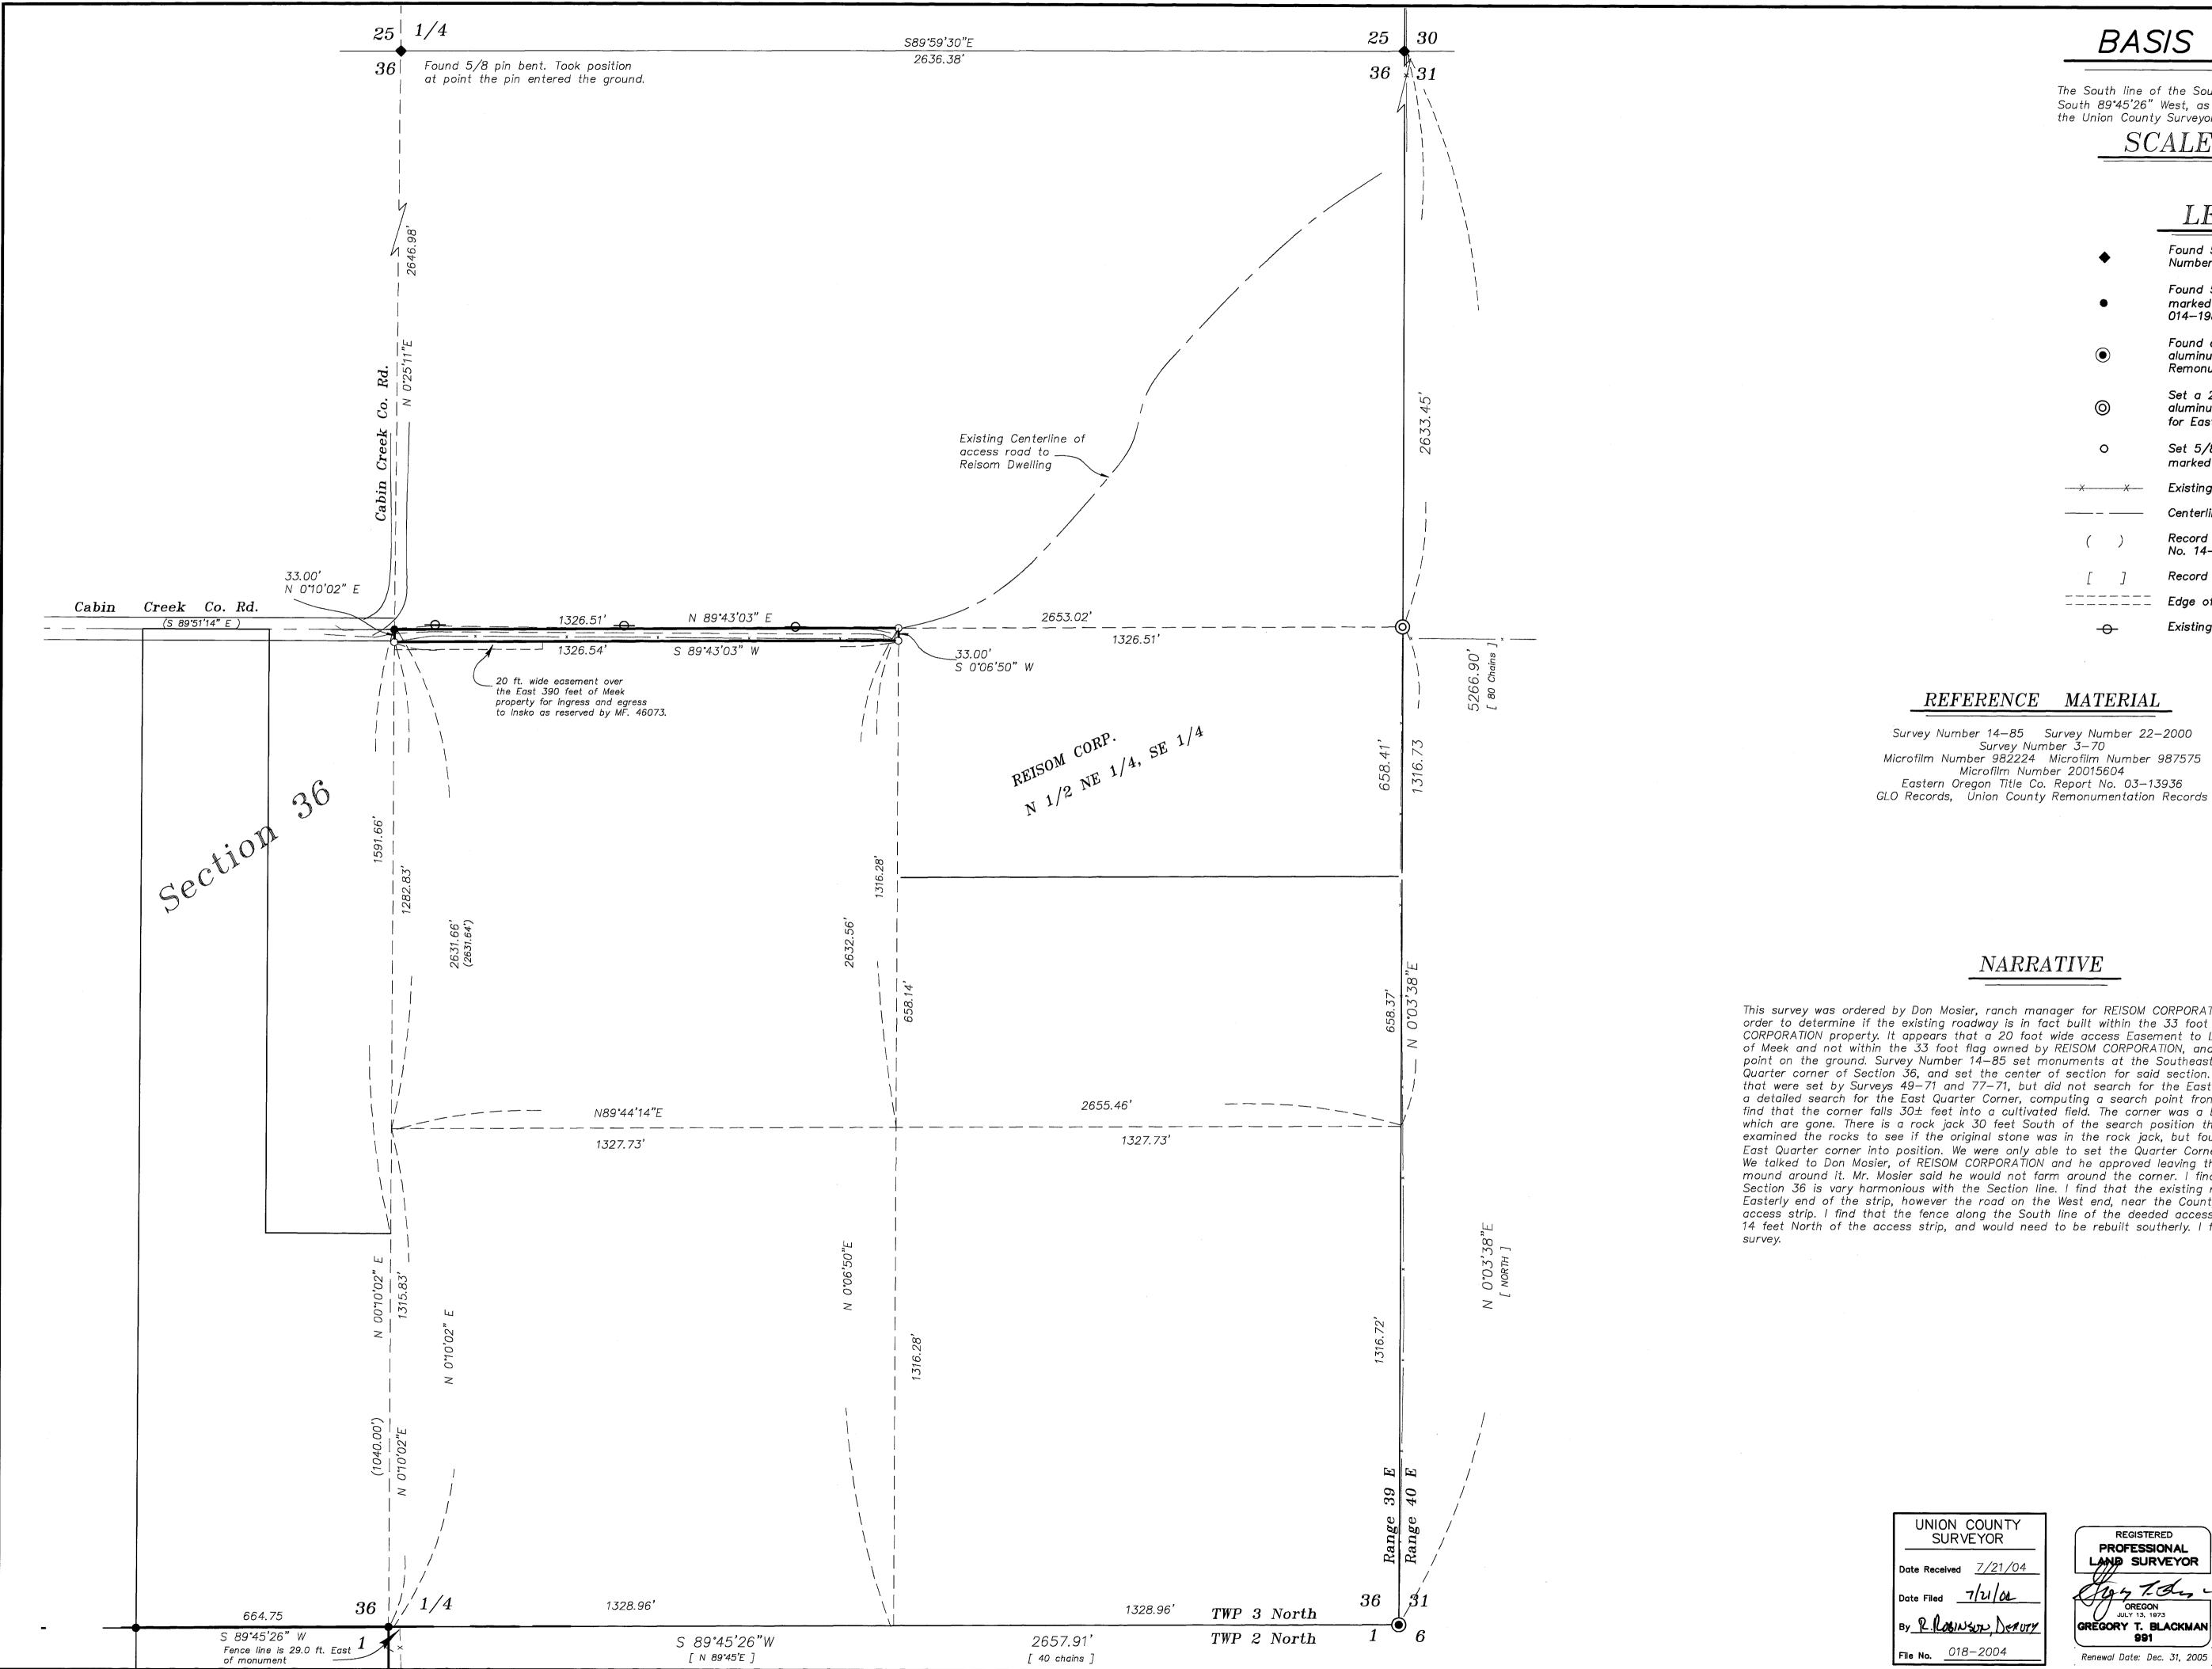
The South line of the Southeast Quarter of Section 36 being South 89°45'26" West, as per Survey Number 14—85 as filed in the Union County Surveyors office.

- Found 5/8" iron pin set by Survey Number 49-71
- Found 5/8" iron pin with plastic cap marked "AP&A" set by survey number
- Found a 2" diameter Aluminum Pipe with aluminum cap as described in Corner Remonumentation record.
- Set a 2 1/2" x 30" Aluminum Pipe with aluminum cap marked as per BLM Manual for East 1/4 corner of Section 36
- Set 5/8"x30" iron pin with plastic cap marked "BGB SURVEY MARKER"
- Existing fence line
 - Centerline of Street
 - Record bearing or distance from Survey No. 14-85
- Record GLO bearing or distance
- Edge of gravel road
 - Existing Power Poles

This survey was ordered by Don Mosier, ranch manager for REISOM CORPORATION to locate the existing access road in order to determine if the existing roadway is in fact built within the 33 foot flag that creates access into the REISOM CORPORATION property. It appears that a 20 foot wide access Easement to Lee Insko and wife lies along the North line of Meek and not within the 33 foot flag owned by REISOM CORPORATION, and Mr. Mosier wanted to be able to locate this point on the ground. Survey Number 14-85 set monuments at the Southeast corner of Section 36, and at the South Quarter corner of Section 36, and set the center of section for said section. Survey 14-85 makes reference to iron rods that were set by Surveys 49—71 and 77—71, but did not search for the East Quarter corner of said Section 36. I made a detailed search for the East Quarter Corner, computing a search point from the Southeast Corner of Section 36, and find that the corner falls $30\pm$ feet into a cultivated field. The corner was a basalt rock with two bearing trees, both of which are gone. There is a rock jack 30 feet South of the search position that had a number of rocks of called size. I examined the rocks to see if the original stone was in the rock jack, but found no marked stone. I then proportion the East Quarter corner into position. We were only able to set the Quarter Corner 15" in the ground before we hit bedrock. We talked to Don Mosier, of REISOM CORPORATION and he approved leaving the monument above ground with a large rock mound around it. Mr. Mosier said he would not farm around the corner. I find that the fence line along the East line of Section 36 is vary harmonious with the Section line. I find that the existing road does fall within the 33 foot strip on the Easterly end of the strip, however the road on the West end, near the County Road is about 15 feet North of the deeded access strip. I find that the fence along the South line of the deeded access strip, is actually North approximately 12 to 14 feet North of the access strip, and would need to be rebuilt southerly. I find no other unusual conditions with this
