$3 \quad N \quad O \quad R \quad T \quad H$ T O W N S H I P

NARRATIVE

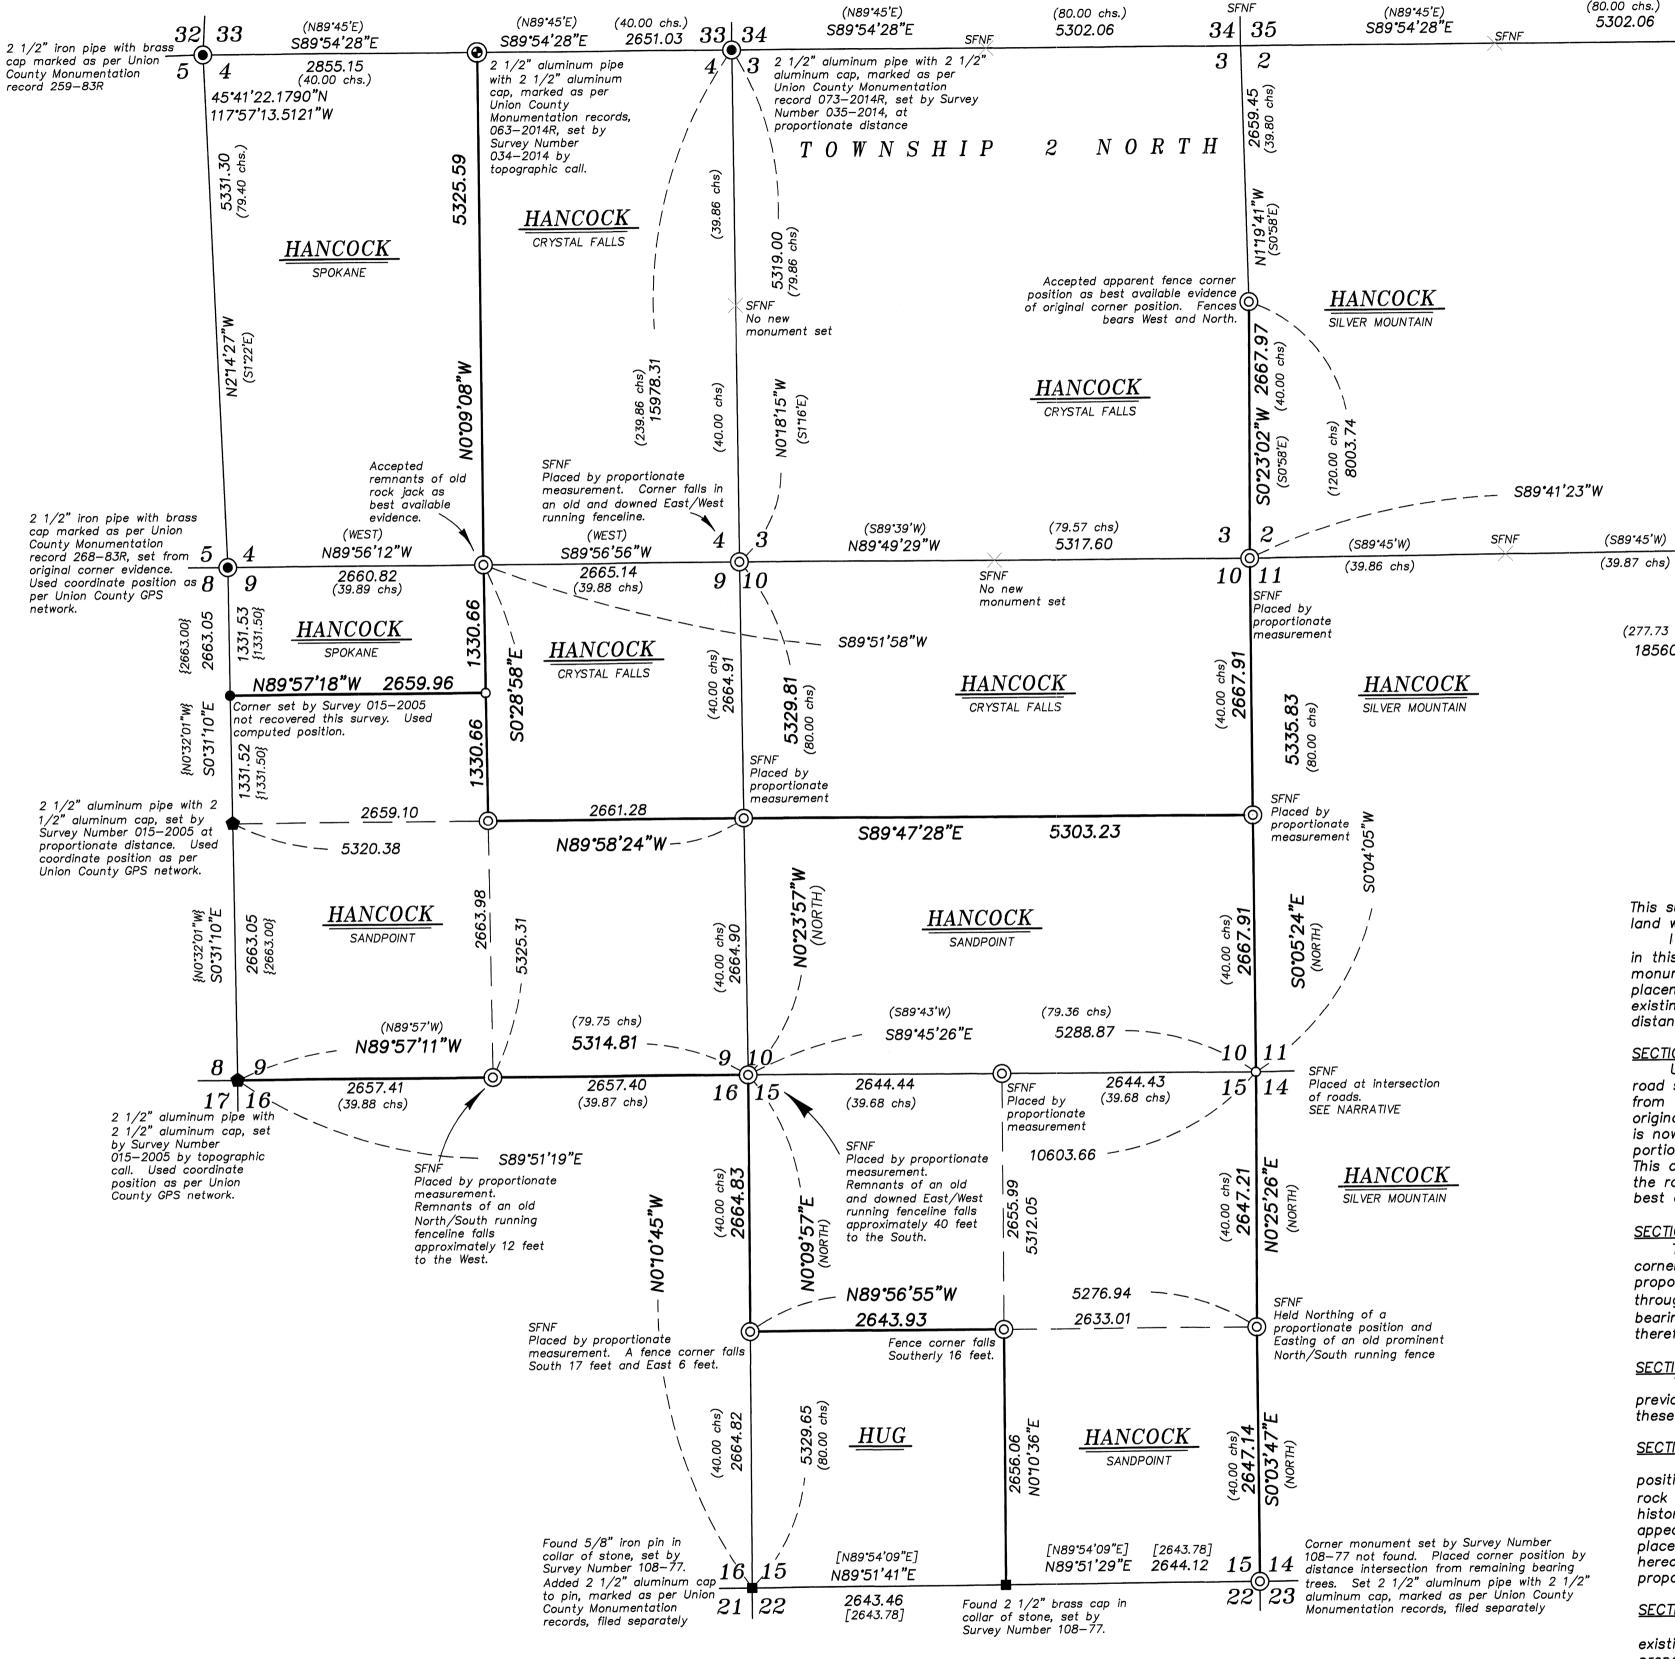
BASIS OF BEARING

Geodetic North at the Southwest corner of Section 33, Township 3 North, Range 39 East of the Willamette Meridian, as determined by GPS observation

SCALE: 1"=1000'

Found monument as noted, marked as per Union County Monumentation records

Found 5/8" iron pin with 2 1/2" aluminum cap, marked as per Union County Monumentation record 064-2014R, set by Survey Number 14-85

Found 2 1/2" aluminum pipe with 2 1/2" aluminum cap, marked as per Union County Monumentation records, 063-2014R, set by Survey Number 034-2014

$2 \frac{1}{2}$ aluminum pipe with $2 \frac{1}{2}$ aluminum cap, set by Survey Number 015-2005, positioned by Union County GPS

5/8" iron pin with 2 1/2" aluminum cap, set by Survey Number 015-2005, not recovered by this survey

Found monument as noted, set by Survey Number 108—77

Set 2 1/2" aluminum pipe with 2 1/2" aluminum cap, marked as per Union County Monumentation records, filed separately

Set $5/8" \times 30"$ iron pin with 2 1/2" aluminum cap, marked as per Union County Monumentation records, filed separately

Record measurement as per field notes of GLO contract no. 382, dated March 23, 1881, executed by Rufus S.

Record measurement as per Survey Number 108-77

Record measurement as per Survey Number 015-2005

Corner searched for, not found

At the North quarter corner position, there is a prominent rock jack that falls within 4 feet of a proportioned position. Due to this harmonious fit as well as its proximity to an original found corner, I accept the position of the rock jack as the original corner position. At the Northeast, Southeast and South 1/4 corner positions, I find evidence of historic lines of possession, evidenced by downed barbed wire. However, I can find no distinct fencelines. Construction appears to be mostly wire strung between existing trees. Finding no distinct lines, I find it difficult to rely on these for placement of corners. I place these corners at proportionate position. I show approximate positions of the old fencelines hereon. I find no evidence of either GLO corner or lines of possession at the East quarter corner and place this by proportion as well.

As with all previously mentioned sections, I find no remaining GLO evidence in the corners of Section 3. There is an existing fenceline at the East quarter corner position. In the North/South direction, it falls very harmoniously with a proportioned distance, though the Eastings of a proportioned position fall about 40 feet to the West. At the fence corner position, a decayed stump matches the original call to the Northwest bearing tree, though no marks could be found, nor cauld the stump be accurately dated due to its decayed state. The position of the fence does seem to match with the 1 degree Northwest skew that shows in the original GLO plat as it heads to the North, though this bearing is not repeated as the line heads to the South to the SE corner of the Section. Despite this angle break, due to the fact that both the positions of the Northeast and Southeast corners of Section 3 are proportioned, and both from quite some distance, I find that the position of the fence corner to have relative harmony, and therefore accept this corner as being the best available evidence of the original corner position.

All other lost corners were placed by proportionate measurement as per BLM Manual of Instruction 2009. Basis of bearings for this survey is the same as Surveys 034-2014 and 035-2014. The basis of bearing reported as being the Southeast corner of Section 33 was intended to say the Southwest corner. I find no other unusual conditions with this
