True Geodetic North at the corner common to Sections 5, 6, 7 and 8, Township 4 South, Range 41 East of the Willamette Meridian as determined by GPS observation (NAD-83 (1991) datum) as per Survey Number 030-2014

SURVEY NUMBER 039-2021

NARRATIVE

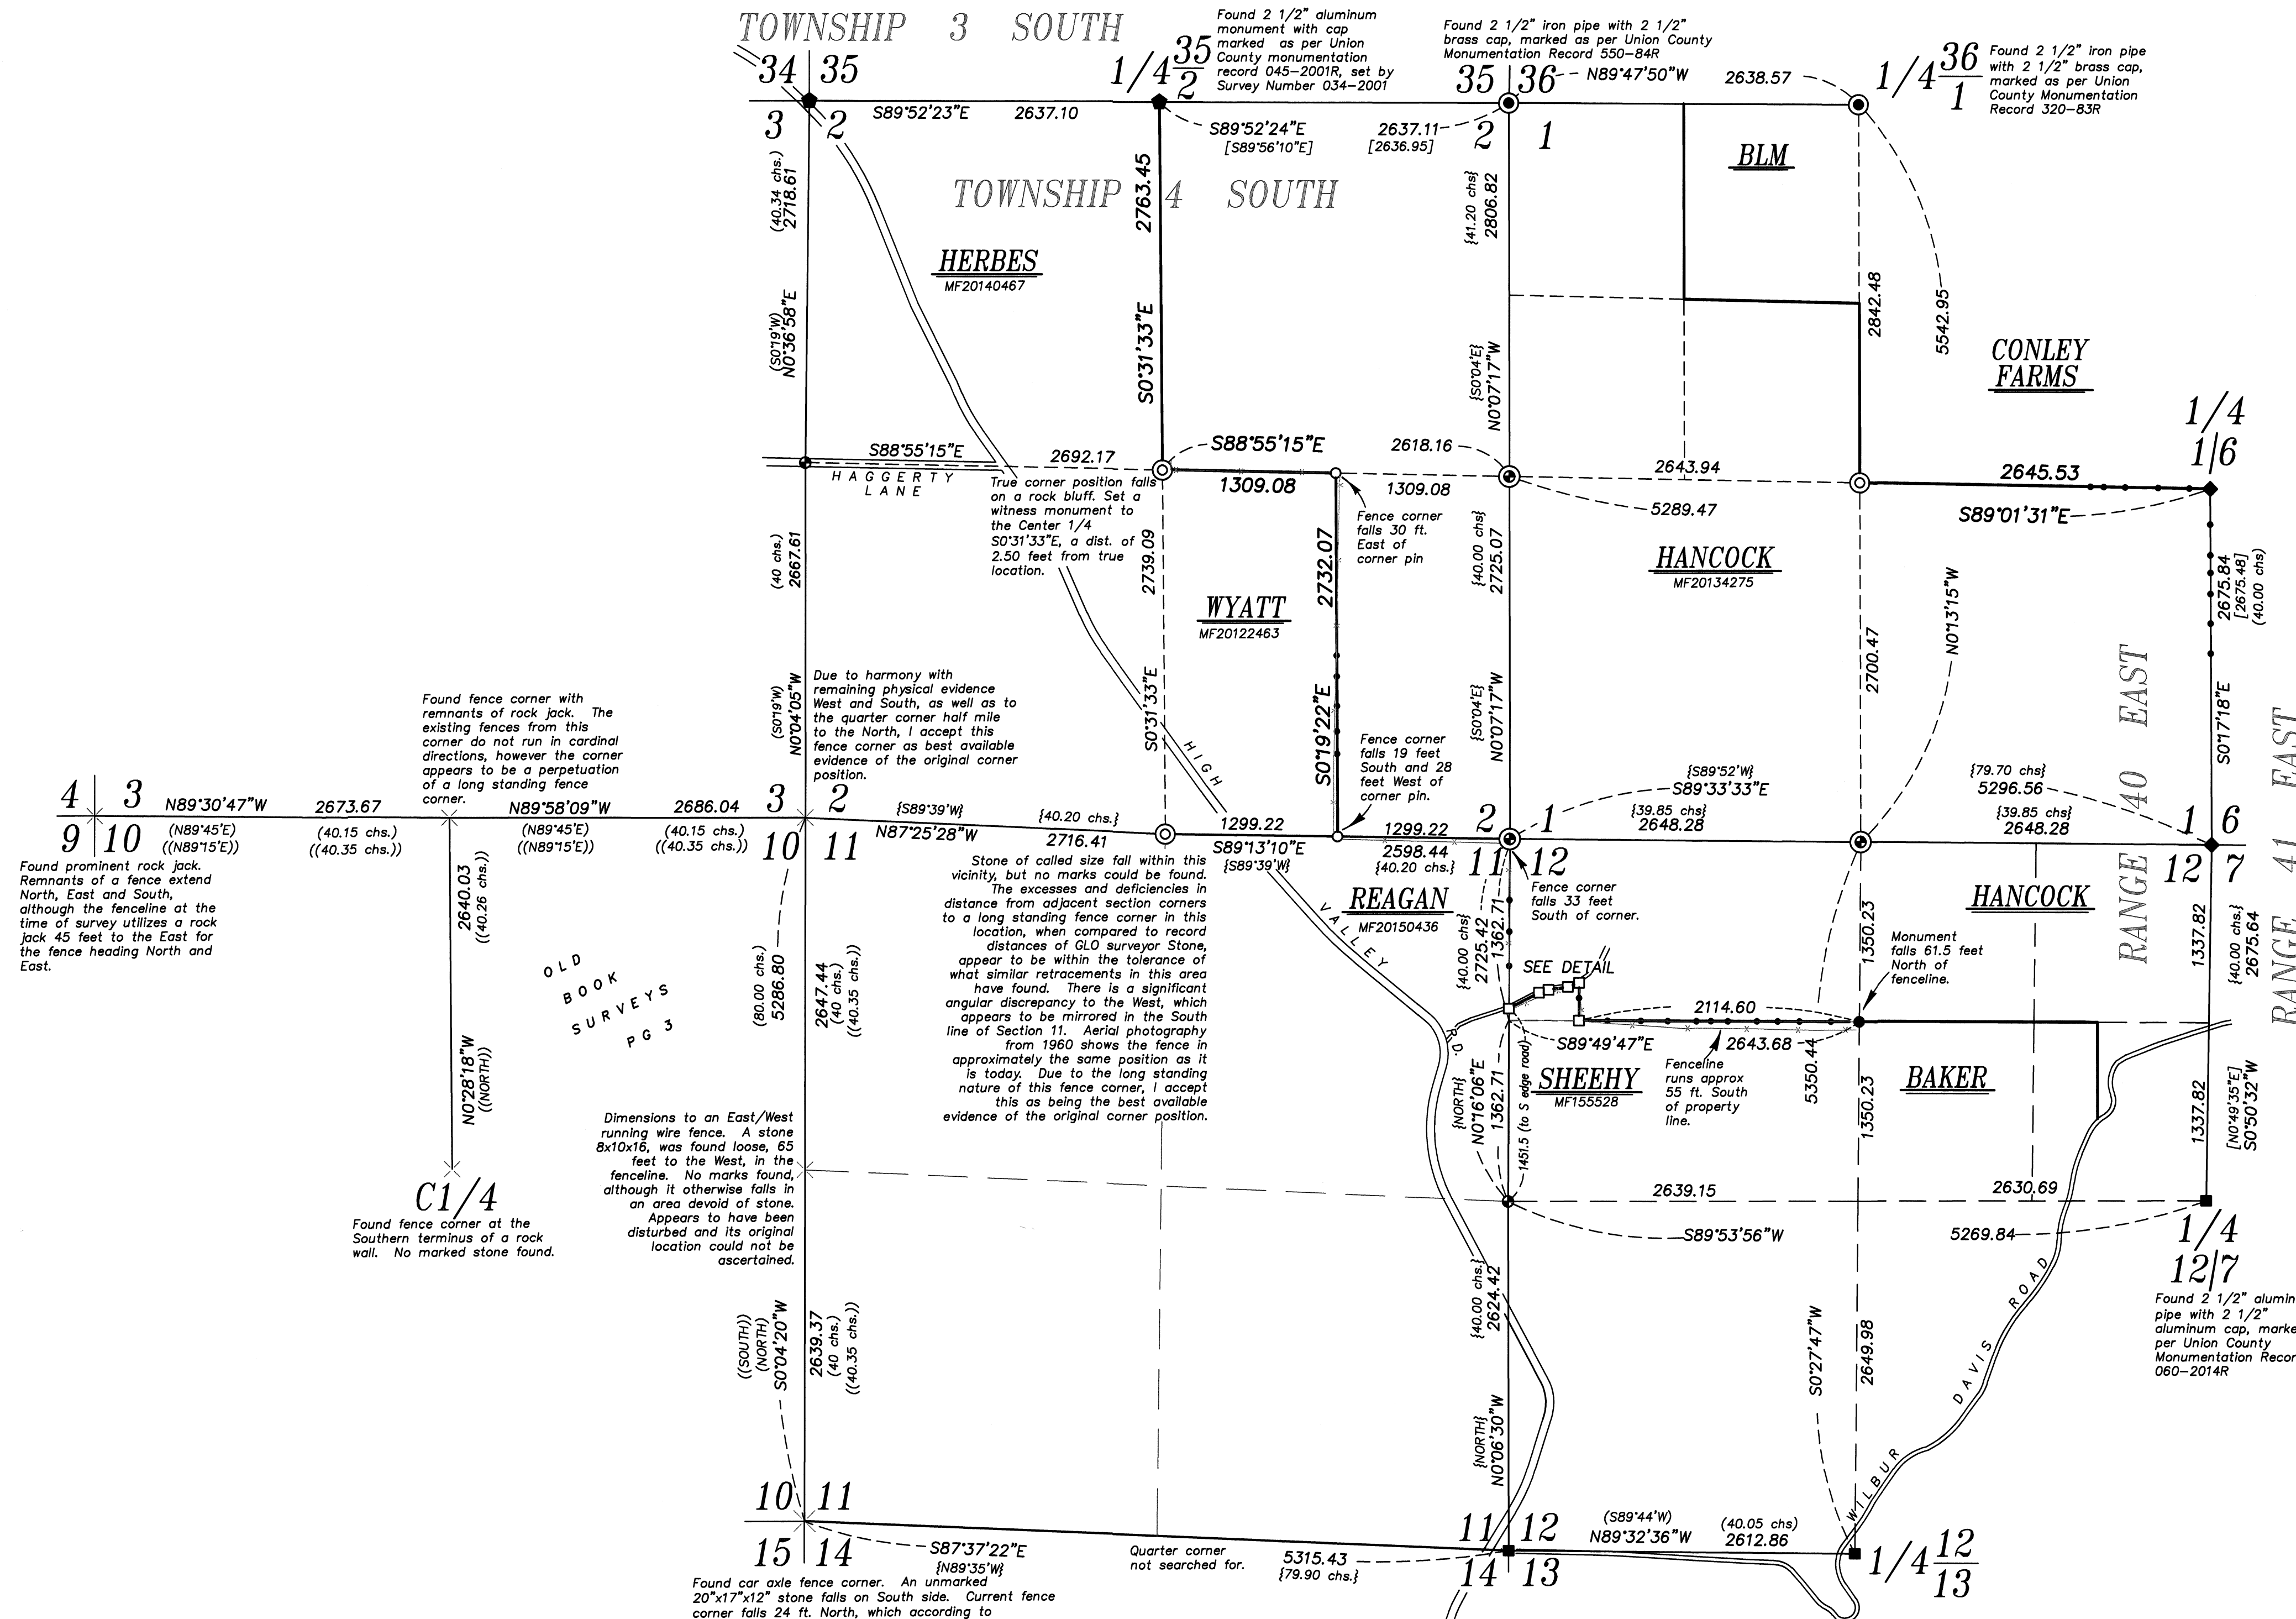
Found prominent rock jack. Remnants of a fence extend North, East and South, although the fence line at the time of survey utilizes a rock jack 45 feet to the East for the fence heading North and East.

Found fence corner with remnants of rock jack. The existing fences from this corner do not run in cardinal directions, however the corner appears to be a perpetuation of a long standing fence corner.

Dimensions to an East/West running wire fence. A stone 6x10x16, was found loose, 65 feet to the West, in the fence line. No marks found, although it otherwise falls in an area devoid of stone. Appears to have been disturbed and its original location could not be ascertained.

Stone of called size fall within this vicinity, but no marks could be found. The excesses and deficiencies in distance from adjacent section corners to a long standing fence corner in this location, when compared to record distances of GLO surveyor Stone, appear to be within the tolerance of what similar retracements in this area have found. There is a significant angular discrepancy to the West, which appears to be mirrored in the South line of Section 11. Aerial photography from 1960 shows the fence in approximately the same position as it is today. Due to the long standing nature of this fence corner, I accept this as being the best available evidence of the original corner position.

Found car axle fence corner. An unmarked 20"x17"x12" stone falls on South side. Current fence corner falls 24 ft. North, which according to landowner was reconstructed from its original location to accommodate a water line. Measurement to car axle.

This survey was done at the request of Patrick Marolla on behalf of Hancock Forest Management, land manager for the land within. Mr. Marolla wanted select lines in Sections 1, 2, and 12 monumented and posted prior to a timber harvest. Section 1 was subdivided by Survey 022-2015. Finding monuments harmonious with said survey I set the center quarter as per the break of said survey. Section 2 required the placement of the South quarter corner to break the section. I find a long standing fence corner in the approximate location and relatively harmonious with the Southeast corner of the Section. An old pile of stones falls along the Southwest side of this fence corner, with several stones of called size, however no marks could be found. I continue my search to the West. Section 10 was subdivided by Kimbrell in survey recorded in Old Book Survey Pg. 3. I find long standing lines of possession to match harmoniously with said Old Book Survey, but can find no confirmable and undisturbed original monuments set by this survey. I show courses to existing fence line and evidence hereon to show the harmonious relationship between existing lines of possession and the courses of said Old Book survey. I believe these represent the best available evidence of the original corner positions. Based on the fence corner at the Southwest corner of Section 2 being the best available evidence of the original corner, I calculate a proportionate position for the South quarter corner of Section 2 and find that it falls 43 ft. North and 57 feet West of the fence corner mentioned earlier. Holding the fence corner would put a curious angular discrepancy in the South line of the Southwest quarter of Section 2, however, this discrepancy also seems to appear in the South line of Section 11. As these sections were part of a completion survey done by GLO surveyor Stone, there is the possibility that a closure onto the original GLO surveyor's work was not properly completed. As the difference between a measured and record distance are within what one could expect from retracing Stone's work in this area when comparing the fence corner location to adjacent corners, I accept this fence corner as the best available evidence of the original corner position. The irregular trapezoid shaped tract in the Northwest quarter of Section 12 calls to the South side of a Wagon Road. The legal description makes a distance call from the North 1/16th corner to the point of beginning. The distance from the West quarter corner of Section 12 to the South side of the existing road matches very well with sum of the distance call of the deed from the N 1/16th and a nominal 1320 ft. As there was never a N1/16th corner monument set, I conclude that the existing road is in the same location as the one called for in the deed. I therefore hold the South side of the existing road as constructed. The legal description then proceeds Easterly 32.5 rods, more or less. Though this is an approximate call, there is a patent ambiguity in the sense that there is no qualifying call as to what the distance is to. An existing fence corner falls very close to the distance call. Though the distance is long, when measured along the road, by perpendicular offset to the section line it falls very close to the 32.5 rod call. I therefore hold the existing fence corner for the Easting of the Northeast corner of this portion of property as I feel it is the only physical representation of the intent of the deed. Subdivision of sections is as per BLM Manual of Instructions 2009. Fencelines are off as shown. I find no other unusual conditions with this survey.
