CERTIFIED RECORD OF LAND CORNER MONUMENTATION

INDEX NO. L-18

DIAGRAM
 T5S R41E
 W1/16
 C ----- C
 S14
 1994

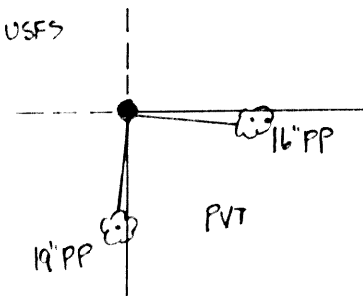
Sketch

A Ponderosa Pine, 16" dia., bears S86°20'E, 33.4 ft., scribed: 1/16CW S14 BT

A Ponderosa Pine, 19" dia., bears S02°40'W, 32.2 ft., scribed: 1/16CW S14 BT

Measurements to BT's taken with total station and chain with bearings based on the survey control network; bearings taken to an 8" spike set at top of blaze, extending out 2" +/- . Nailed Bearing Tree (54-3) signs above blaze and Land Survey Monument (54-9) signs on back of each tree as required. Painted a 6" red band above Bearing Trees signs. Set 1/2" brass disc at base of blaze stamped: "L. MILLER PLS 2513". Spike and nail in brass disc on vertical line. Set steel fence post with Land Survey Monument (54-9) and Property Boundary (54-2) signs alongside monument. Set steel fence post with 54-2 sign East 50' and South 50' from the monument.

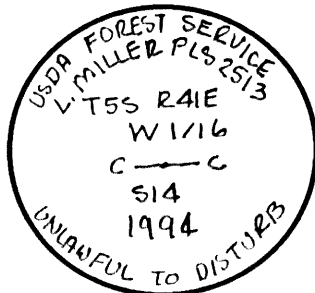
Monument Detail

Set 2" O.D. x 30" ~~galvanized iron~~ pipe 26" in ground with 2" aluminum cap, with magnet and flared ends, stamped as shown on the DIAGRAM, in a mound of stone with 3 ft. base.
