CERTIFIED RECORD OF LAND CORNER MONUMENTATION

F-12

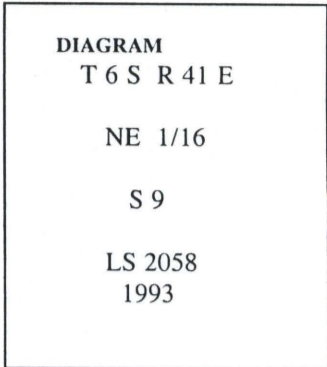
Description of corner evidence found:

Description of monument and accessories I established to perpetuate the original location of this corner:

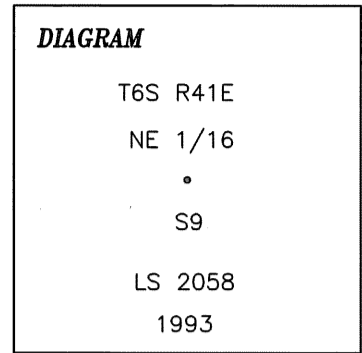
Typical USFS Cap

3 1/4" USFS aluminum cap on aluminum pipe marked as shown in corner diagram in small stone mound.
