Map of Survey
 Lot 5 and the West half of the adjacent
 vacated alley within Block 9
 Hannah's Addition to
 The City of Union
 UNION COUNTY, OREGON

SURVEYED FOR	NE Oregon Housing Authority	
SURVEYED BY	R. G. R.	11-94
Scale: 1" = 60'	Drawn by: R. G. R.	11-94

SURVEY NUMBER 054-1994

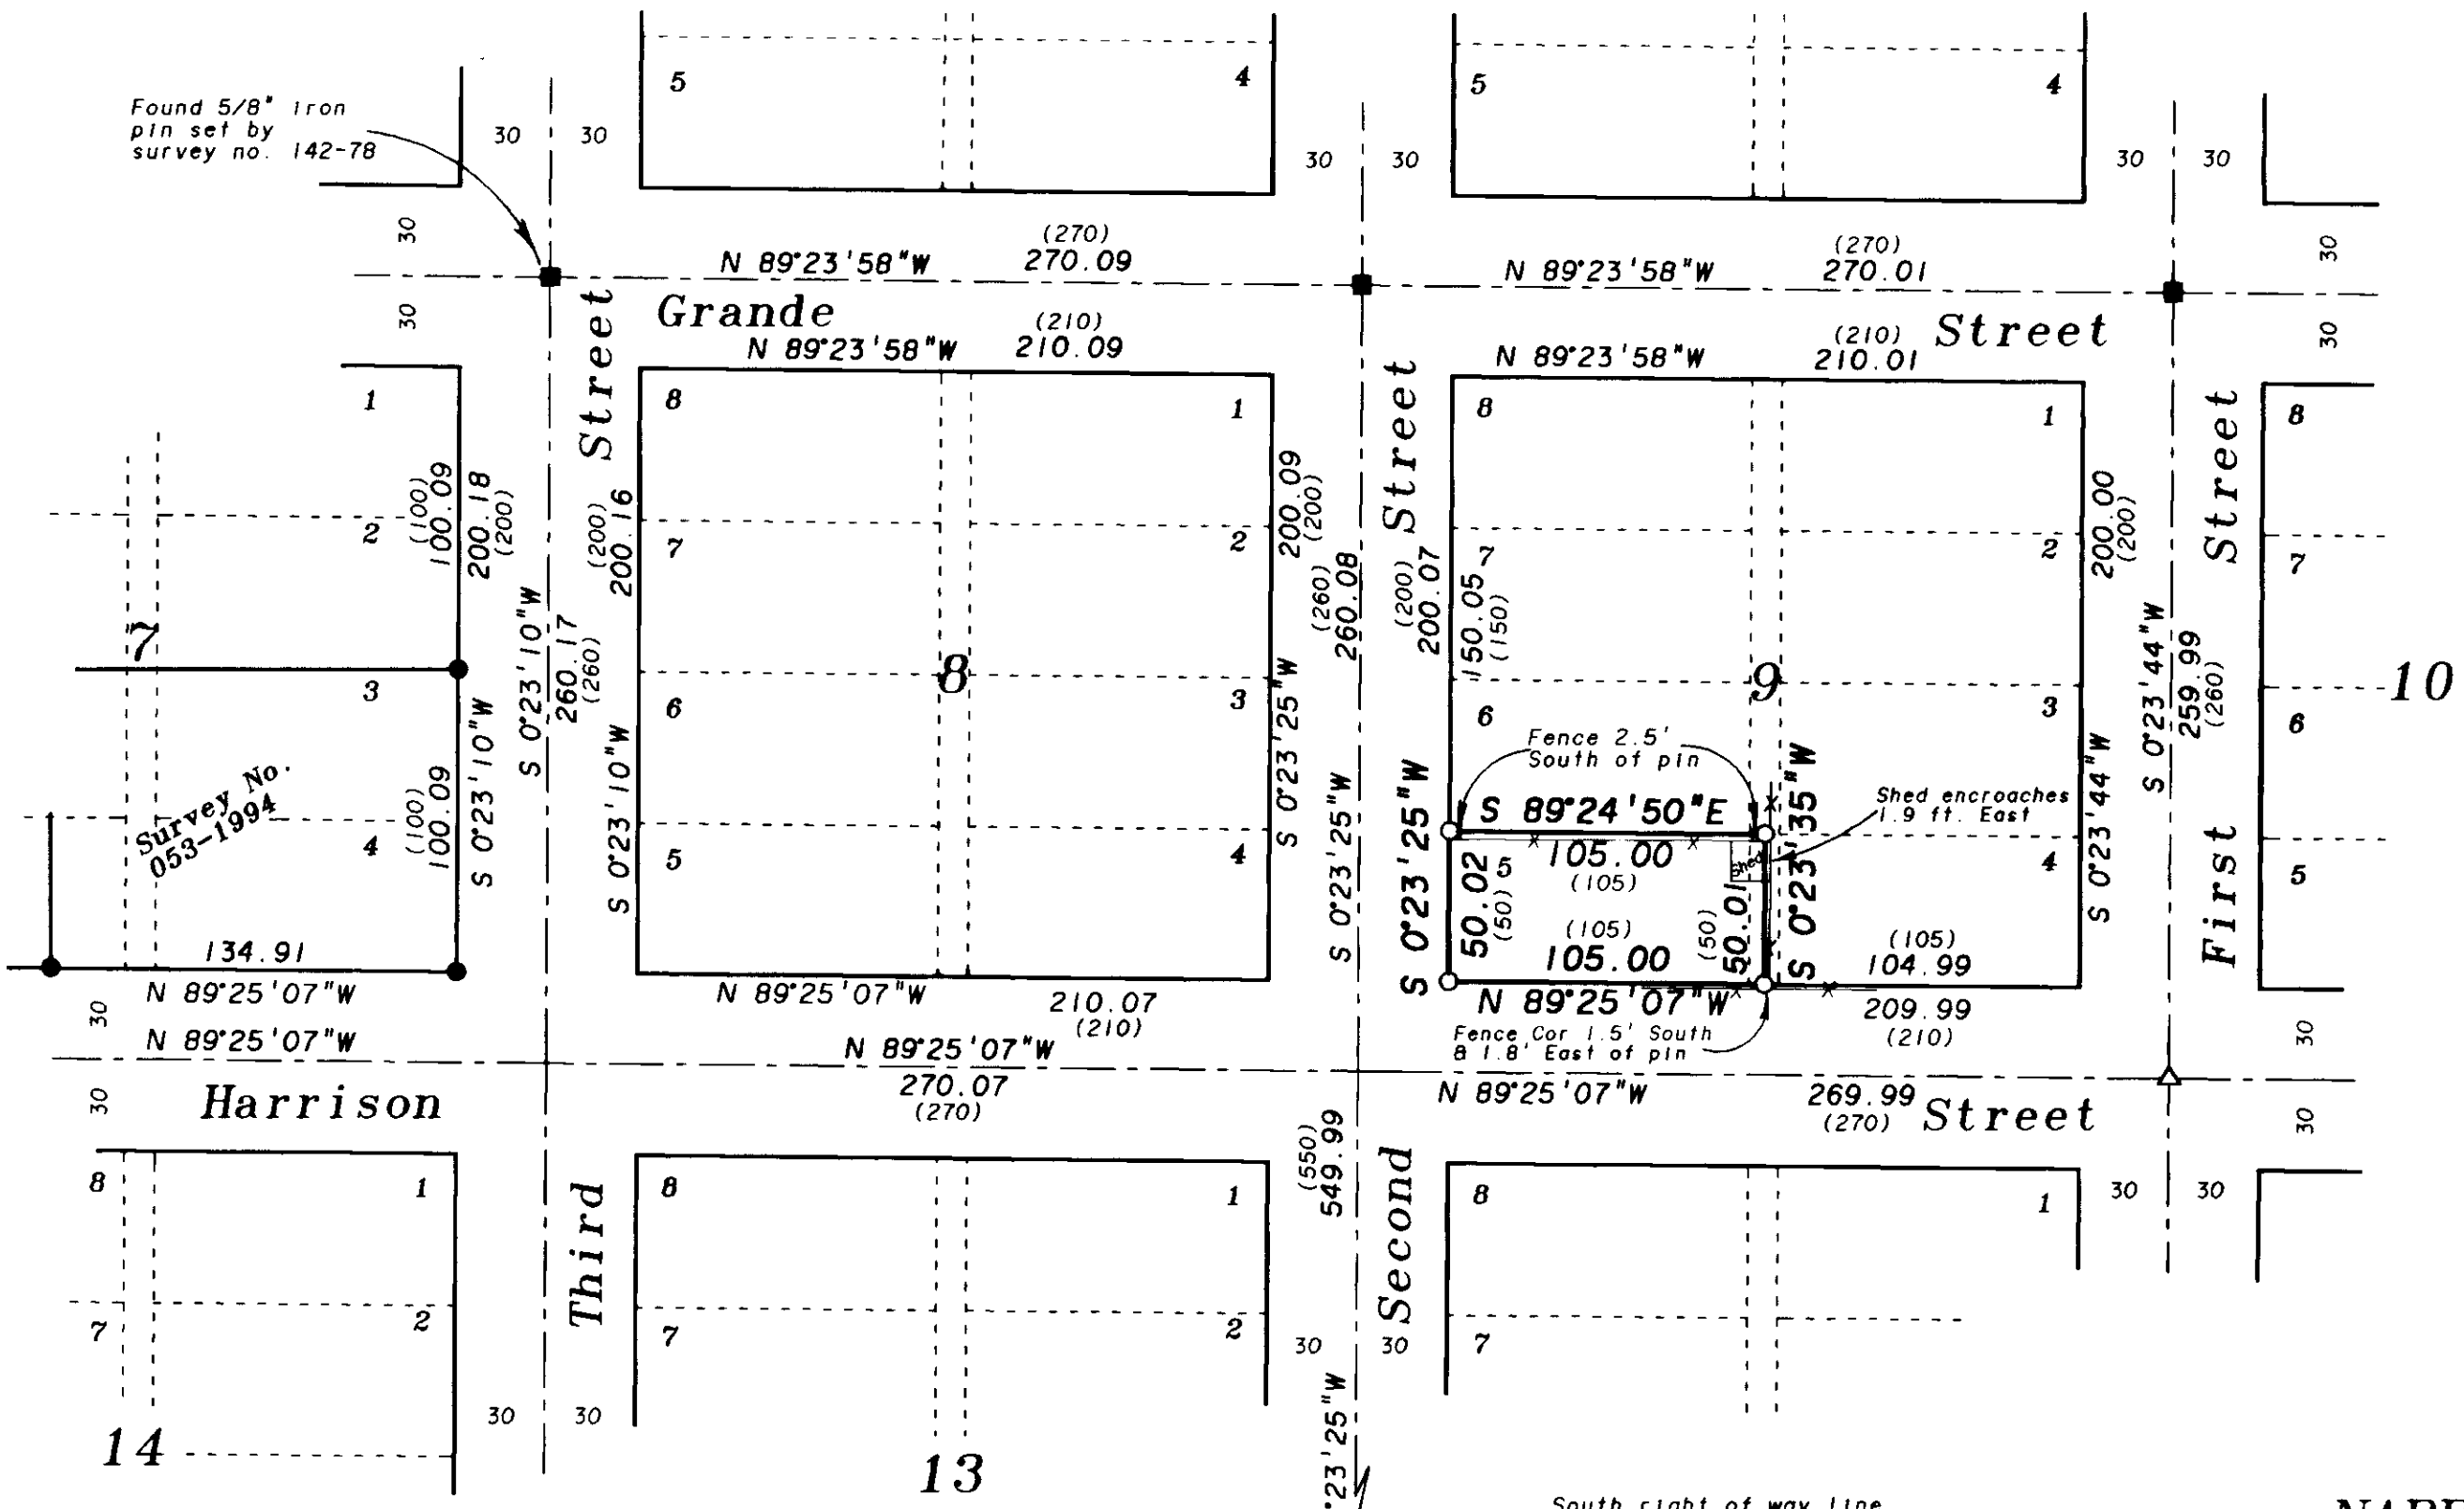
Solar observation taken at the Southeast corner of Section 13, Township 4 South, Range 39 East of the Willamette Meridian.

Alleys within the blocks shown were vacated by Ordinance 365 Series 1982 and recorded as Microfilm No. 107139 in the Union County deed records.

This survey was done at the request of Steve McKay on behalf of the Northeast Oregon Housing Authority. I base the location of Block 9 on the found monuments as shown. There was a 5/8" iron pin at the intersection of Harrison and 1st Streets which was destroyed by sewer construction. This pin was located by previous surveys. I use the location of the pin prior to its destruction for the intersection position. To locate the intersection of Harrison and 2nd Streets, I intersect a line from the previously stated position to a point 30 feet South of the south line of Block 7, as determined by survey no. 053-1994, with a line between the found monuments shown along the centerline of 2nd Street. From these intersection positions, I determine the exterior and interior lots of Block 9 in the standard manner. The alleys in the blocks shown were vacated by deed microfilm no. 107139. I find the existing fence along the North to be 2.5 feet South of the true North line of Lot 5, with the fence along the East line of the tract being approximately 2 feet East of the true centerline of the vacated alley. I find the existing shed at the Northeast corner of the tract encroaches onto the property to the East by the same amount. I find no other unusual conditions on this survey.
